Solar PV Module Quality Risks

A Summary of CEA's Findings in the Field

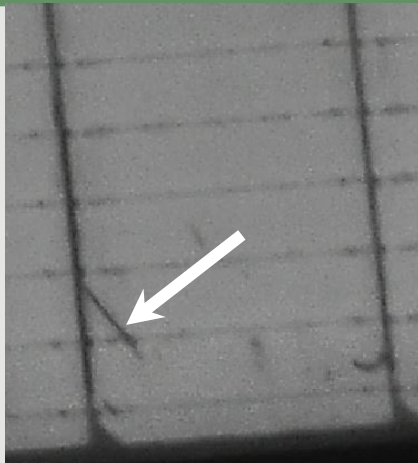
83% of Sites Had **LINE CRACKS**

- 1) Wafer imperfections
- 2) Light impacts to the cell/module
- 3) Pressure on the cell during module manufacturing:
 - Stringing
 - Lamination

- 1) Increase in internal series resistance leading to minor power loss.

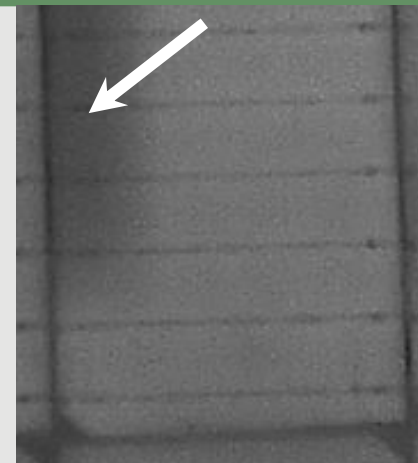
73% of Sites Had **SOLDERING ANOMALIES**

- 1) Indicative of poor soldering process control during manufacturing.
- 2) Occurs when one or more of the busbars that connect each cell to the adjacent cell are not adhered properly.

- 1) Reduce the cell efficiency
- 2) In severe cases, hotspots can form and cause damage to the modules.

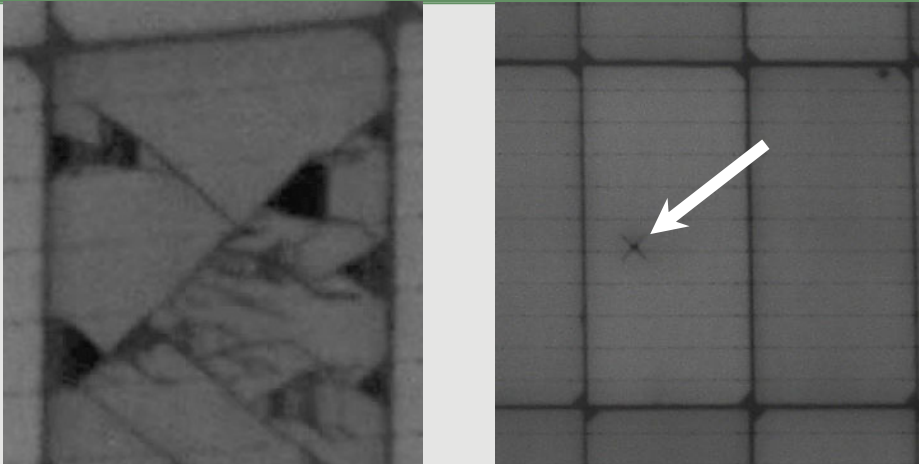
76% of Sites Had **COMPLEX CRACKS**

- 1) Stress on the module from handling, severe weather, etc.
- 2) Impacts to the modules, caused by:
 - Tools used during installation
 - Hail or storm debris
- 3) Microcrack growth

- 1) Hot spots that can lead to thermal damage
- 2) Large inactive areas significantly reduce performance

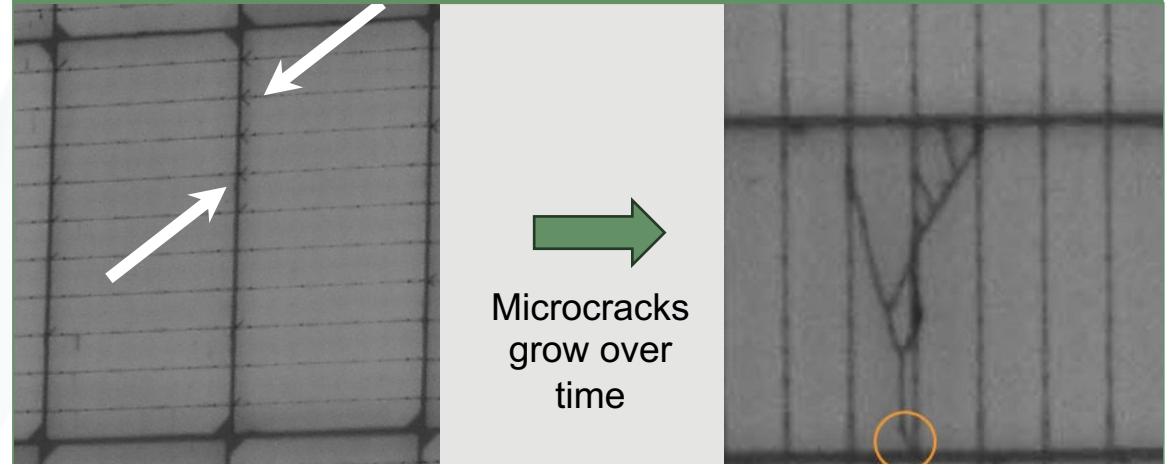
29% of Sites Had **EDGE RIBBON CRACKS**

- 1) Form where the interconnect ribbon (or wire) crosses the edge of the cell.
- 2) They often start as a tiny line or V-crack and can grow during the solar module's lifetime.
- 3) Highest risk in half-cut cells, 81% of sites with half-cut cells have this defect.

- 1) Based on CEA's experience, edge ribbon cracks are more likely to grow (compared to other microcrack types).
- 2) Impact on safety and performance (isolated areas, diode activation, hot spots).

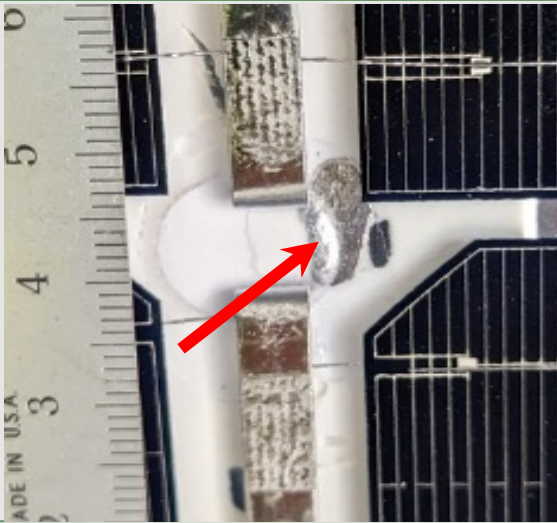
55% of Sites Had FOREIGN MATERIALS

- Unwanted substance or debris that's present within the module.
- It results from dirt, dust, debris, or other particles getting into the module during manufacturing.

- Reduced efficiency and potential degradation over time.
- May reduce internal creepage/clearance distances required for safety.

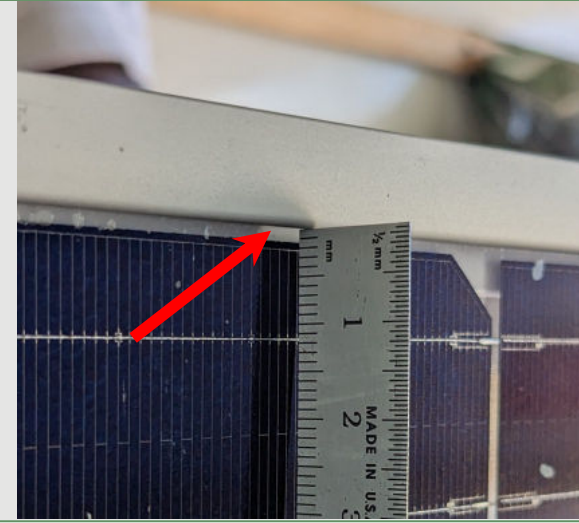
52% of Sites Had CELL TO EDGE OF GLASS DEFECTS

- The minimum distance between internal components and the edge of the glass is determined by the module design to ensure sufficient electrical insulation and to certify the module to the IEC safety standards.
- This defect can arise from manufacturing inconsistencies, misalignment during assembly.

- Internal arcing (risk of fire)

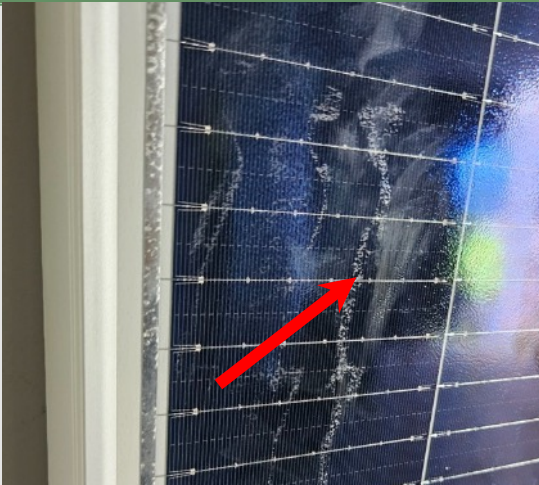
45% of Sites Had **GLASS STAINS/MARKS/ENCAPSULANT DEFECTS**

- Glass stains, marks, or encapsulant residue that cannot be cleaned off.
- Some stains/marks can occur at the site (e.g. aluminum smears), but they can also be an indicator of inadequate quality assurance at the factory.

- Can increase module soiling and decrease performance

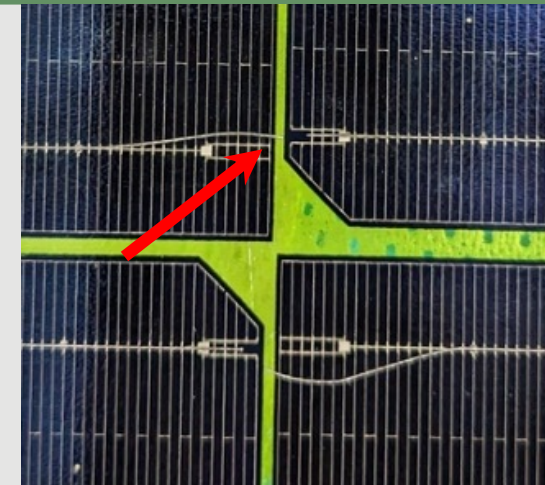
41% of Sites Had **STRINGING WIRE/RIBBON OFFPAD DEFECTS**

- An off-pad ribbon is a segment of the ribbon or string that is not connected to the solder pads, either on the cell or on the bussing ribbon.
- This results in an area that is not properly electrically connected to the rest of the string and may have high series resistance.

- Performance loss
- Risk of hot spot development (severe cases)

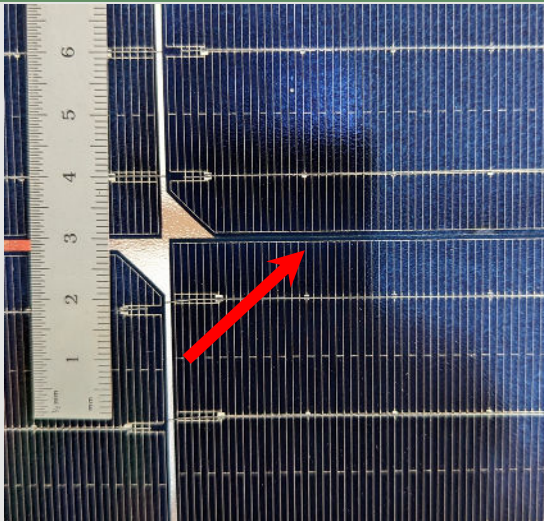
41% of Sites Had **CELL to CELL DEFECTS**

- Cell to cell defects refer to misalignment affecting the distance between cells
- These defects can arise from manufacturing inconsistencies, misalignment during assembly

- Reduced efficiency and hot spot development

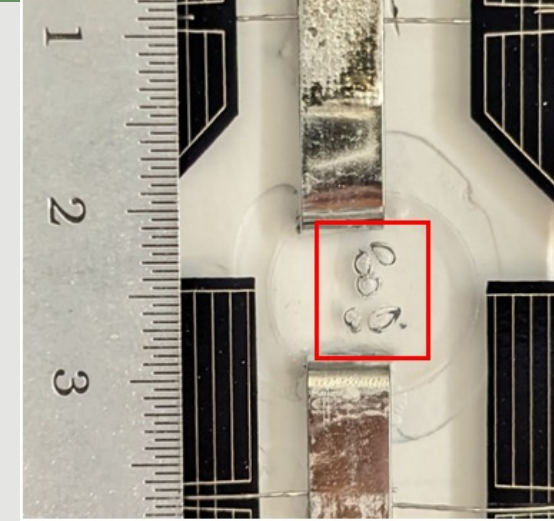
41% of Sites Had **LAMINATE BUBBLES**

- Voids or bubbles are small pockets of air or gaps trapped within the layers of the solar module.
- They can form during the manufacturing process if the layers of the module don't bond together perfectly.

- Reduced efficiency and weakening of the modules.
- Depending on location, internal short circuit and risk of fire
